# ATSPM Case Studies

TESC Workshop – December 6, 2023

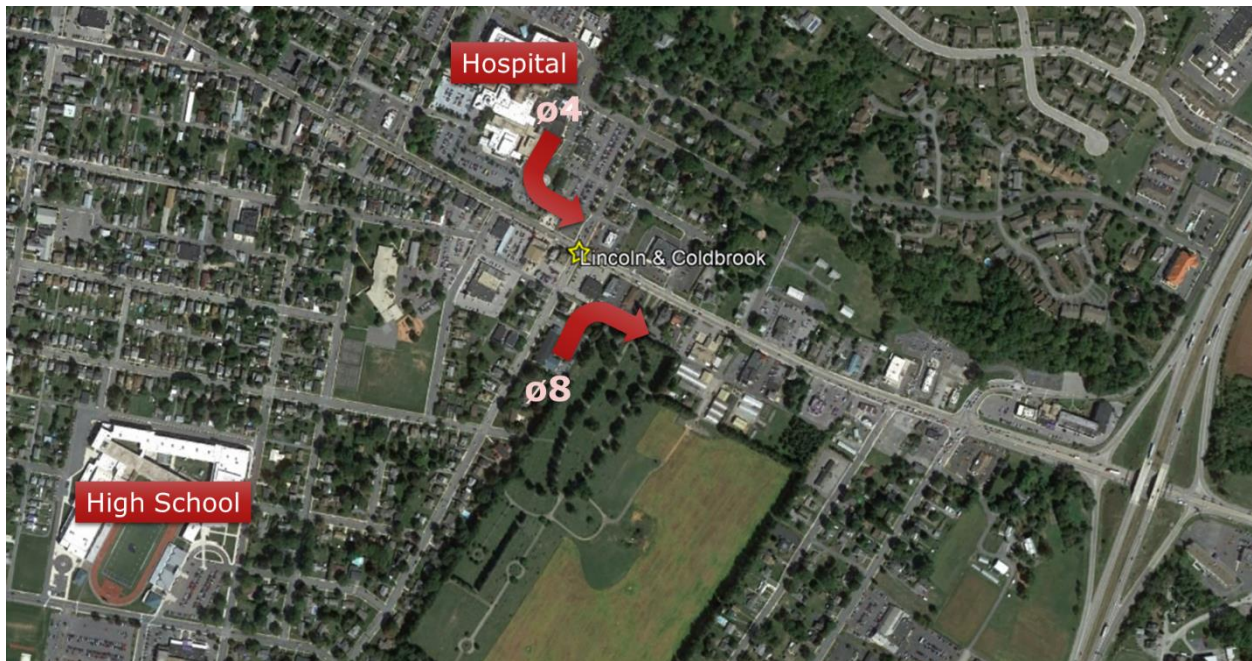
**Background:** A concern was raised by Chambersburg Hospital regarding left turns on the side street approaches at the intersection of Lincoln Way & Coldbrook Avenue in Chambersburg, PA, especially around hospital shift changes. The municipality suggested adding left turn phases to mitigate the concern.

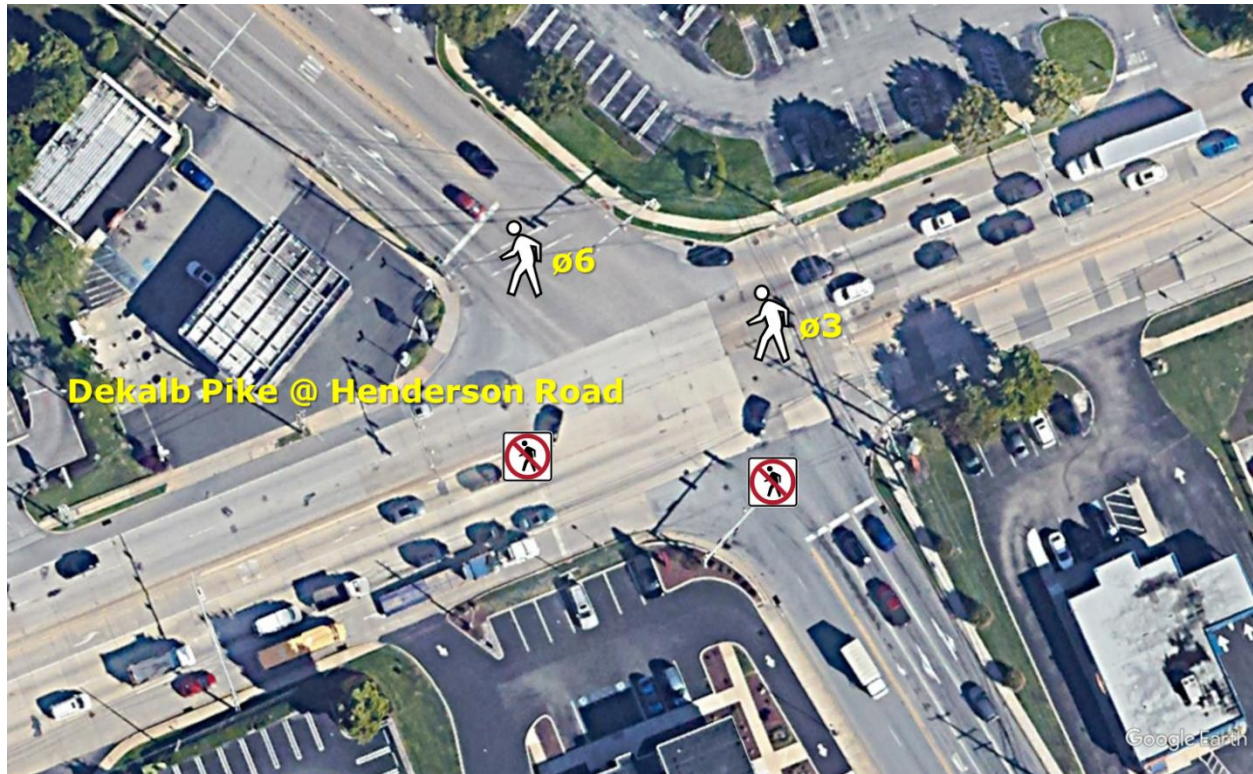
**Background:** If the split times at a traffic signal running a coordination timing plan are not long enough to accommodate the pedestrian walk and clearance times, a phase will go past the designated force off time and cause the coordinator to go into transition mode. The intersection of Dekalb Pike & Henderson Road has pedestrian crossings associated with phases 3 and 6, and is part of a coordinated system with 10 other intersections.

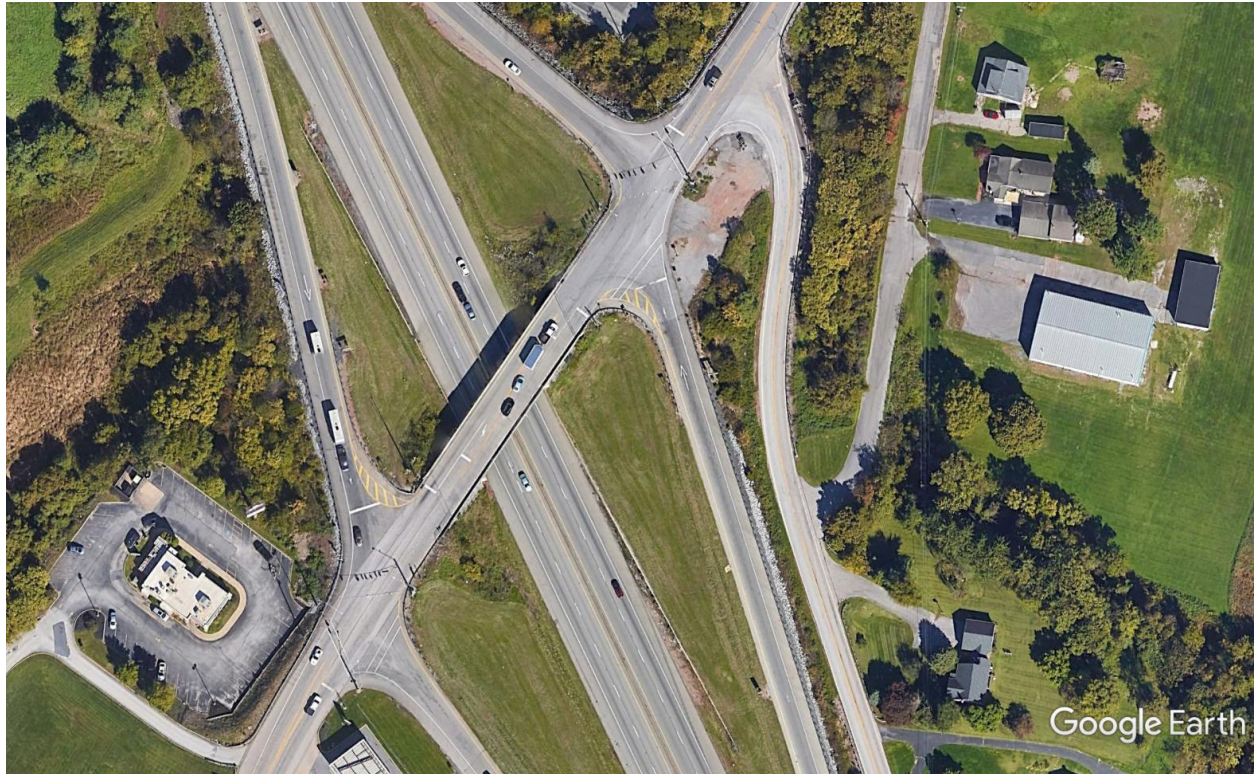
**Background:** Exit 28 from I-83 is a diamond interchange running on a single controller. The phasing is designed for both ramps to have green simultaneously if there is demand on both ramps.
